FENNER LAKE LAKE CLASSIFICATION REPORT

EXECUTIVE SUMMARY

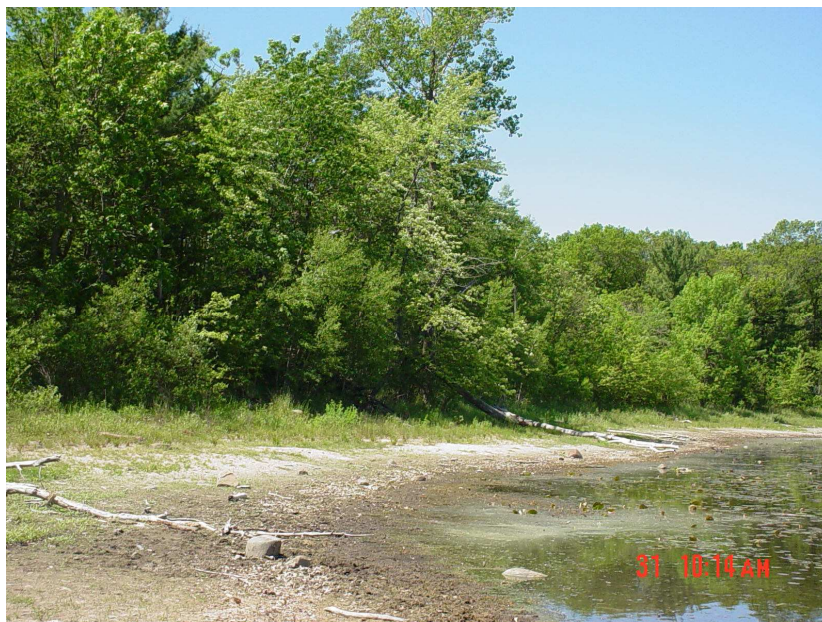
Figure 8: former shoreland wetland area on Fenner Lake now exposed

Wetlands play an important role in maintaining water quality by trapping many pollutants in runoff and flood waters, thus often helping keep clean the water they connect to. They serve as buffers to catch and control what would otherwise be uncontrolled water and pollutants. Wetlands also play an essential role in the aquatic food chain (thus affecting fishery and water recreation), as well as serving as spaces for wildlife habitat, wildlife reproduction and nesting, and wildlife food.

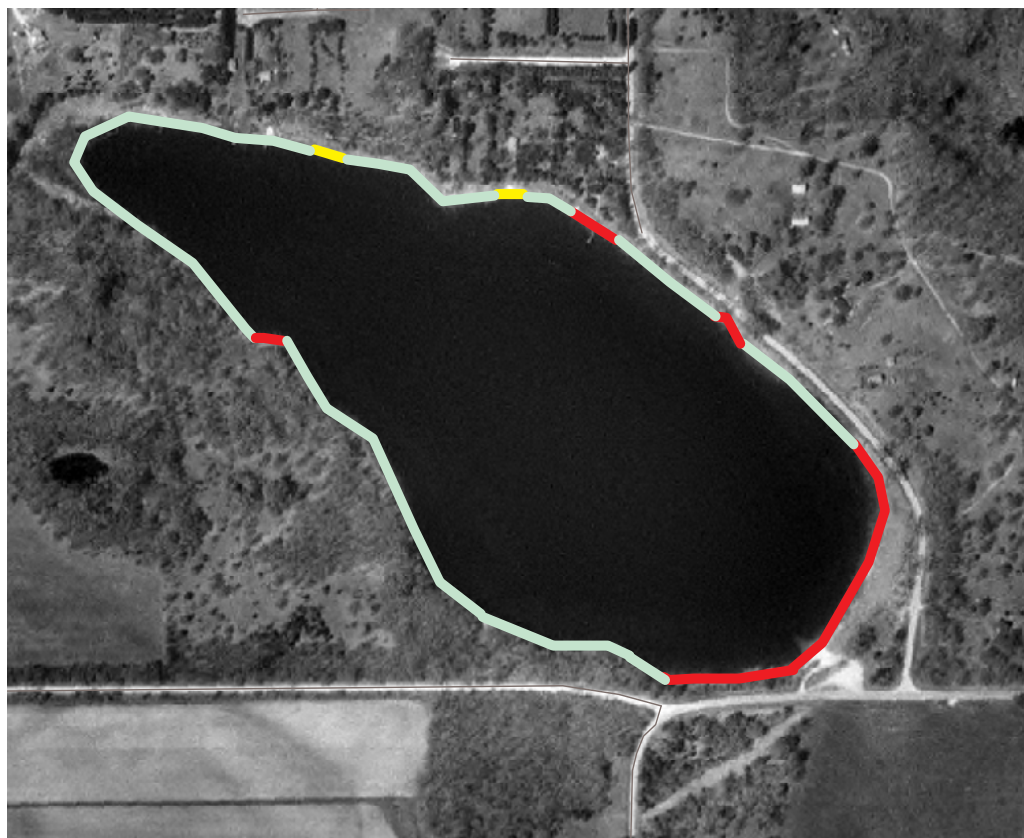
Figure 9: Shoreline of Fenner Lake (2004)

Fenner Lake has a total shoreline of 1.0 miles (5280 feet). About half of the immediate shore area is in residential use (some residences are not visible on the aerial photo below due to heavy tree establishment. Much of the area near the shore is steeply sloped. Buildings are generally located 70 or more feet back from the shore. 76.5% of Fenner Lake's shoreline is vegetated. Several areas of the shore, especially at the east end, have significant erosion currently occurring.

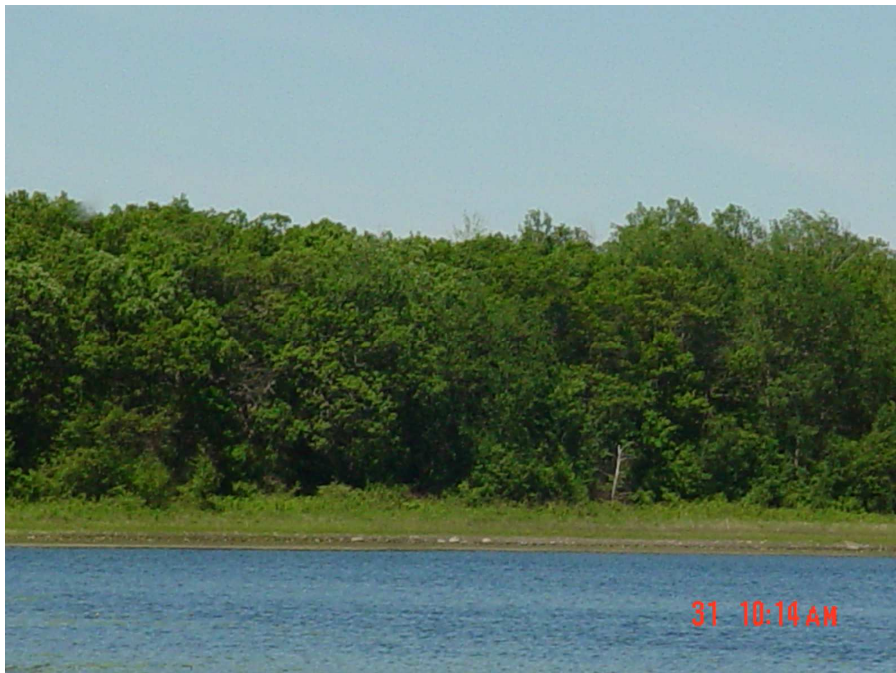
**Figure 13:
Example of
Vegetated
Shore on
Fenner Lake**

Adequate buffers on Fenner Lake could be easily installed on most of the lake by either letting the first 35 feet landward from the water just grow without mowing it, except for a path to the water, or—if something more controlled or aesthetically pleasing was desired—by planting native seedlings sufficient to fill in the first 35 feet.

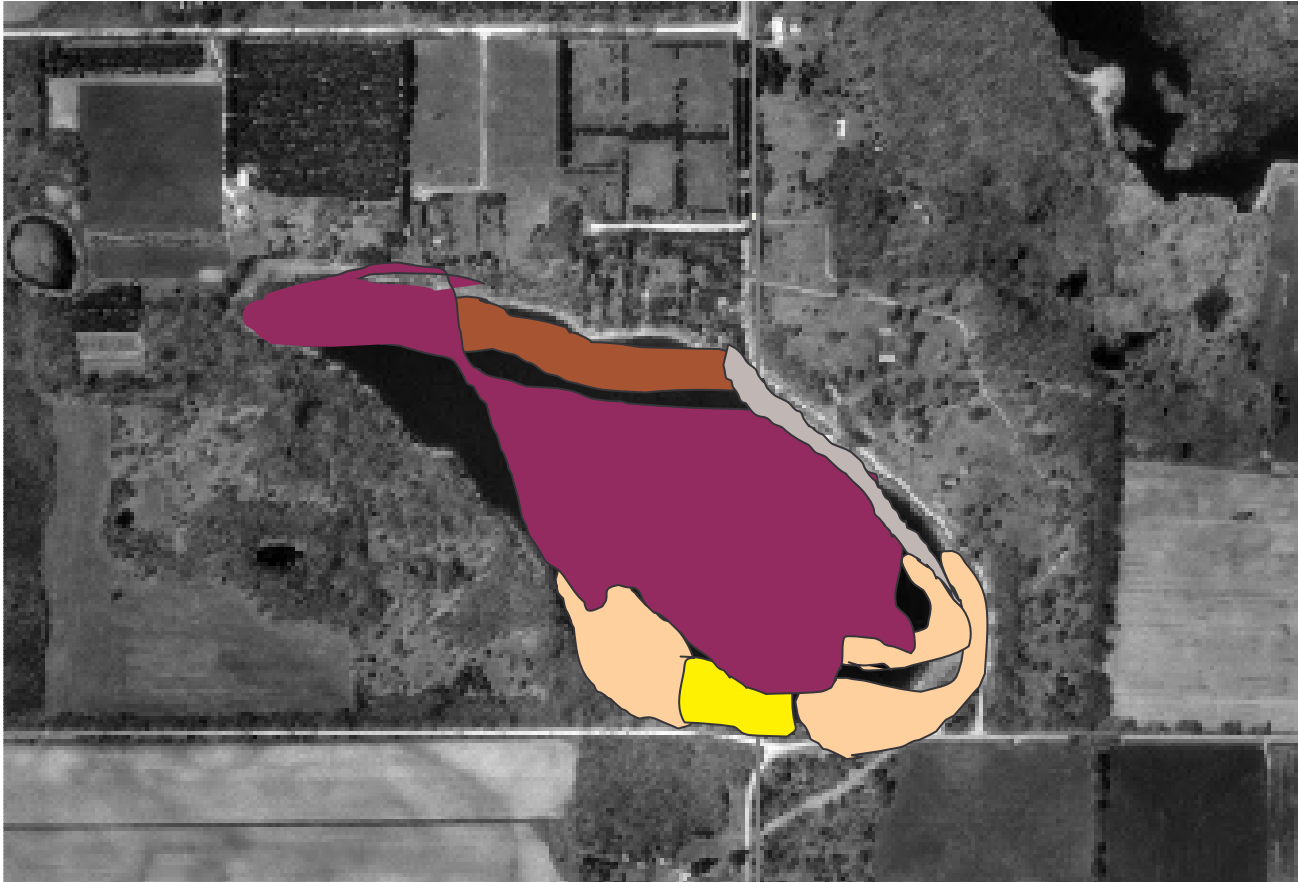
A comparison of the average summer phosphorus level in the lower depths of Fenner Lake (15' and deeper) to the upper depths (surface) shows that average total phosphorus concentrations during the summer months are 36.4 micrograms/liter for 15' depth and below and 27.9 micrograms/liter. This situation should be monitored, because in some of the natural lakes in Adams County, the lower depths are serving as phosphorus “sinks”, adding to the phosphorus in the sediment that may become available to plants and algae in the water column.

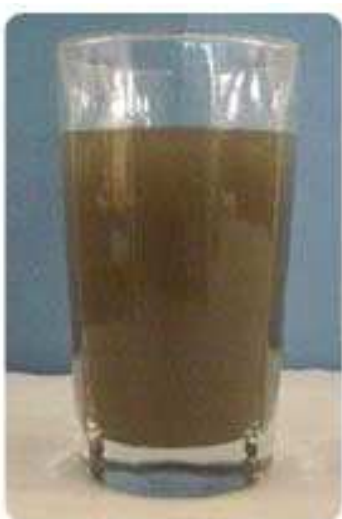
TURBIDITY: Turbidity reflects water clarity. The term refers to suspended solids in the water column—solids that may include clay, silt, sand, plankton, waste, sewage and other pollutants. Turbid water may mask the presence of bacteria or other pollutants because the water looks murky or muddy. In general, turbidity readings of less than 5 NTU are best. Very turbid waters may not only smell, but also tend to be aesthetically displeasing, thus curtailing recreational uses of the water. Turbidity levels for Fenner Lake's waters were 1.38NTU in 2004, 1.9 NTU in 2005, and 1.9 NTU in 2006—all very low levels.

**Figure 31 & 32
Examples of Very
Turbid Water**

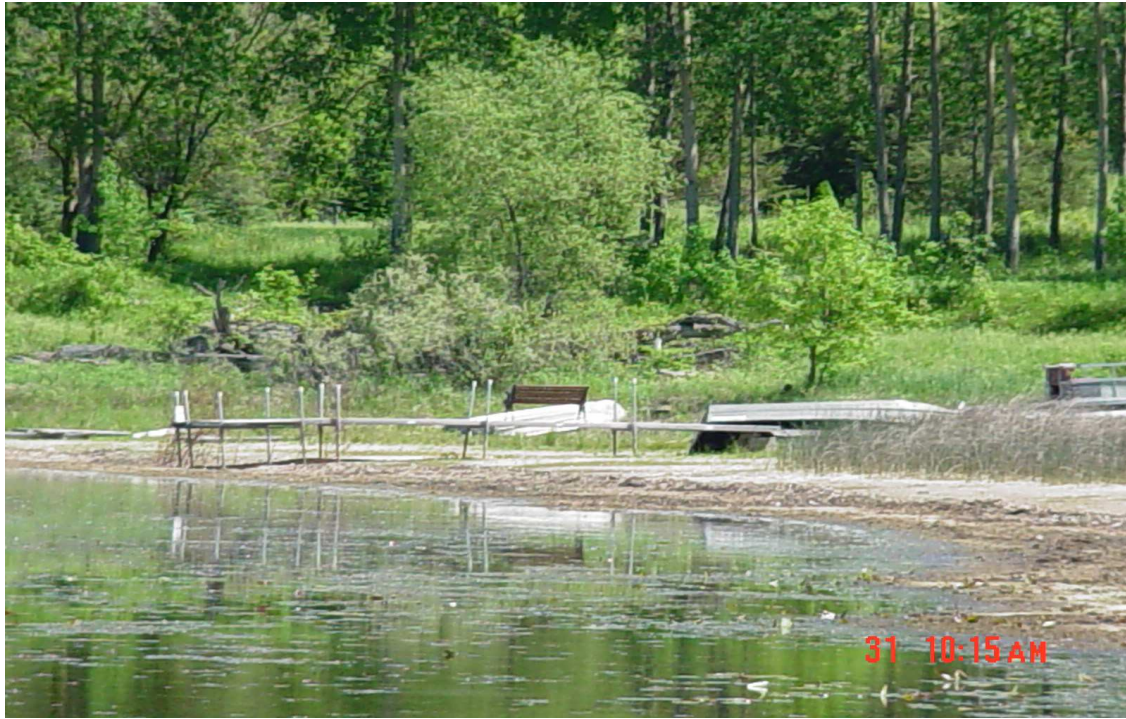
This area extends along approximately 1500 feet of the northeast shoreline, up to the ordinary high water mark and, where there are wetlands, landward of the lake through the wetlands. 12.5% of the shore is wooded; 17.5% has shrubs; 47.5% is native herbaceous cover. The balance of the shore in this area includes a small area of cultivated lawn and pavement. Large woody cover is present for habitat. With human disturbance along this shoreline, the area has some natural scenic beauty, although a paved road runs near the area.

**Figure 46:
Part of FE1**

Filamentous algae were abundant at this site.

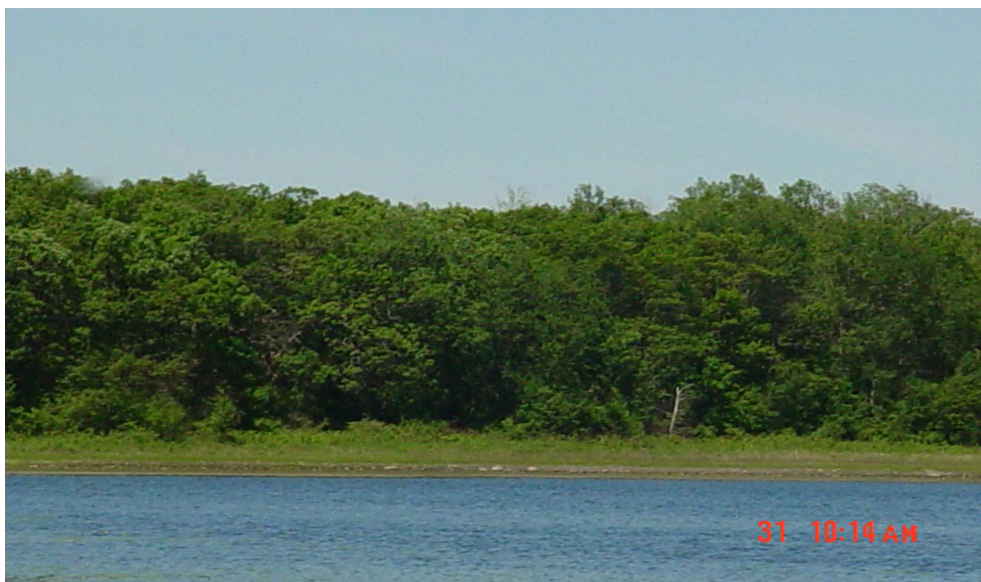
Maximum rooting depth in FE2 was 15 feet. No threatened or endangered species were found in this area. Filamentous algae were not common in this area. Found at this site were six emergent aquatic plant species, three floating-leaf rooted plant species, and thirteen submergent aquatic species.

Figure 47:
Photo of Part of
FE2
